Stray Current Corrosion in Electrified Rail Systems -- Final Report

Dr. Thomas J. Barlo, *formerly* of Northwestern University

May 1995

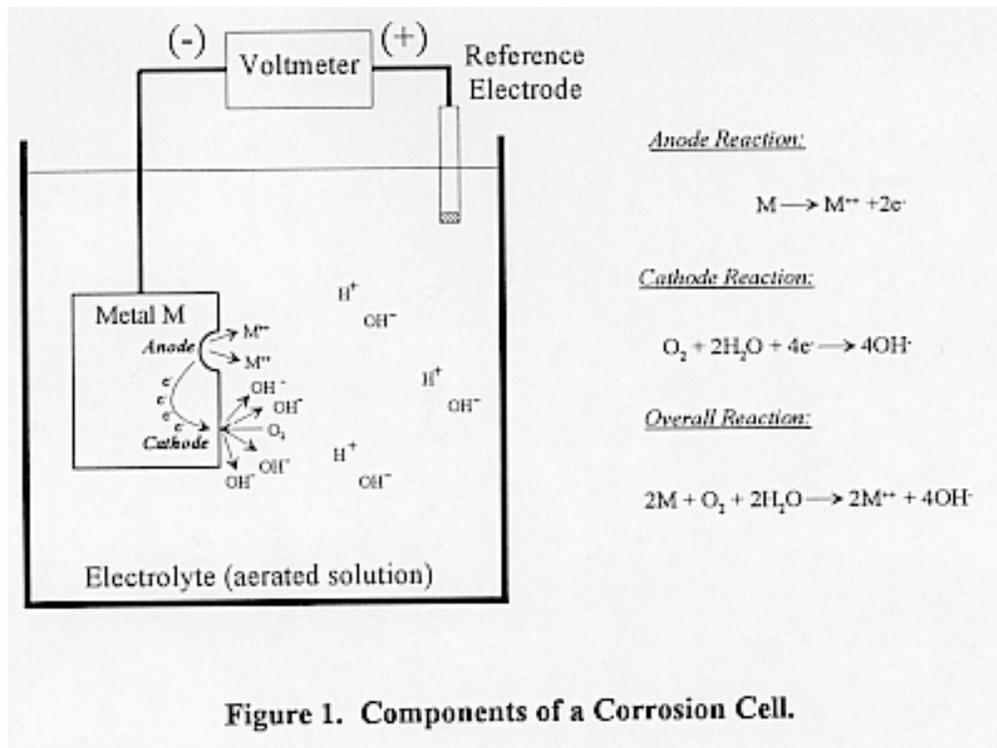
FIGURE 1 illustrates the conditions needed for a corrosion cell. Steel is immersed in an aerated electrolyte and electrically connected to a voltmeter with which to measure the electrical potential of the steel with respect to a reference electrode. When the steel is immersed in the electrolyte, anodic and cathodic regions develop on the steel surface because of differences in the metallurgical phases of the steel, differences in the steel surface condition (e.g., mill scaled in some regions and none in others), or differences in the electrolyte chemistry. Electrical potentials develop between the anodic and cathodic areas, which can be few or numerous, but only a single potential can be measured with respect to the external reference electrode, and that potential is some mixture of the anodic and cathodic potentials. The electrical potential difference between the anodic and cathodic areas produces currents that circulate. In the electrolyte, the current is ionic, while in the metal components the current is electronic. The flow of electrons in the metal and the flow of ions in the electrolyte constitute the current in the cell. If the anode and the cathode are separated by a wire or a long extent of the metal, such as a rail, and the electrolyte is soil, measurable voltage drops will take place along the rail and in the electrolyte. The current measured is the net current and will depend upon the areas of the anodic and cathodic regions, the types of metal for the anode and cathode, and the potential difference between the anodic and cathodic regions.

current to the soil and then to rail near the substation. At the point of discharge, the corroding structure acts as the anode in the corrosion cell shown in Figure 1.

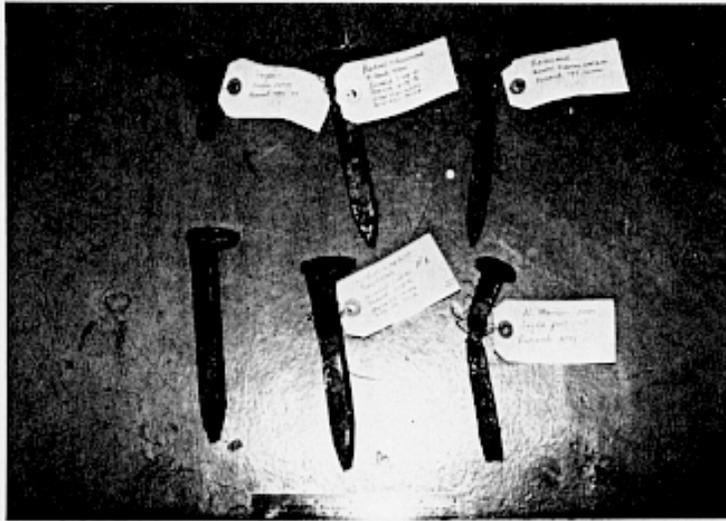
FIGURE 4. Stray-Current Corrosion Effects on Rails and Rail Spikes ca. 1990.

b. Necking of Rail Spikes.

The CTA has had a regular spike replacement problem in certain areas of its at-grade line that tend to be wet. Although the spikes should last about 25 years, they last about 6 months. Corrosion occurs in the neck area of the spike where it enters the wooden tie. The corrosion problem is noted by sway in the passenger cars in the area.

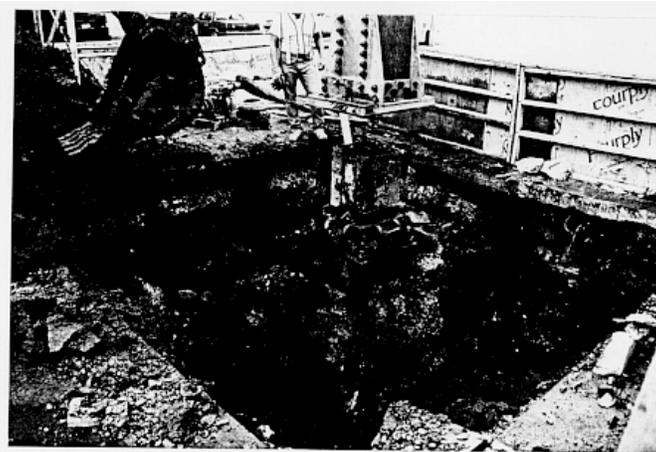
FIGURE 5. Rehabilitation on Concrete Footings for an Elevated Electrified Rapid-Transit System.

a. Removal of Concrete Footings.

The most notable corrosion problem has been with the footings of the elevated portion of the system. Approximately 1,300 columns of the bent areas of the support structure have been affected and are part of an active replacement program. The corrosion problem is noted by movement or sway of the bent when a car passes over it. The sway is the result of corrosion that has taken place on the steel base plate and anchor bolts in the footings of the column of the bents. Although the age of the structure is a contributing factor to the corrosion, stray current is believed to be the most significant factor according to CTA. One indicator of this is the almost simultaneous occurrence of the problem with reduced use of abandoned streetcar rails to reduce the resistance of the negative return circuit.

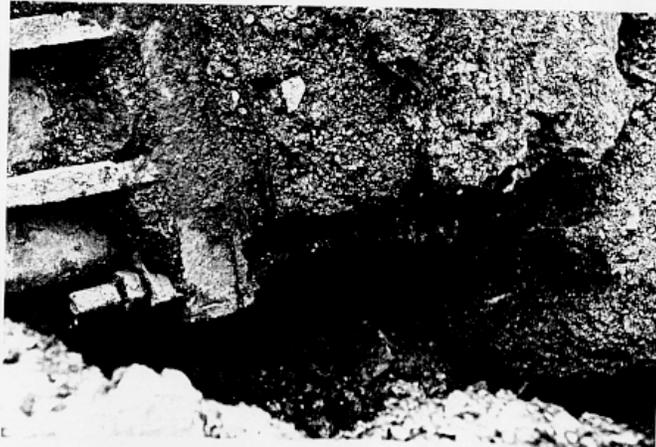
b. Detail of Stray-Current Corrosion on Footing Anchor Bolts.
